Opera Assessment Report Revision 2

Independent Assessment of Eskom's Operational Situation

August 2023

Client:	National Treasury of South Africa	
Project No:	NT015/2022	
Report Title:	Opera Assessment Report – Revision 1	
Report No:	2 NT_Eskom	
Main Authors:	Bartosz Zajda (Dornier) Manswet Banka (Dornier) Klaus Bransch (Dornier) Vladan Dokic (Dornier) Pieter Janse van Rensburg (Dornier) Dr. Thomas von Schieszl (Dornier) Jörg-Schulte Trux (KWS) Ralf Wiescher (KWS) Rainer Zobel (KWS) Axel Meschbiz (RWE) Petros Terzis (RWE)	Volkmar Bobon (STEAG) Dietmar Breuer (STEAG) Dr. Ruth Egyptien (STEAG) Werner Renk (STEAG) Sener Günes (vgbe) Bernhard Michels (vgbe) Dr. Mark Newby (vgbe) Dr. Claudia Stockheim (vgbe) Dr. Oliver Then (vgbe) Dr. Christian Ullrich (vgbe) Dr. Claudia Weise (vgbe)
Date of Issue:	August 2023

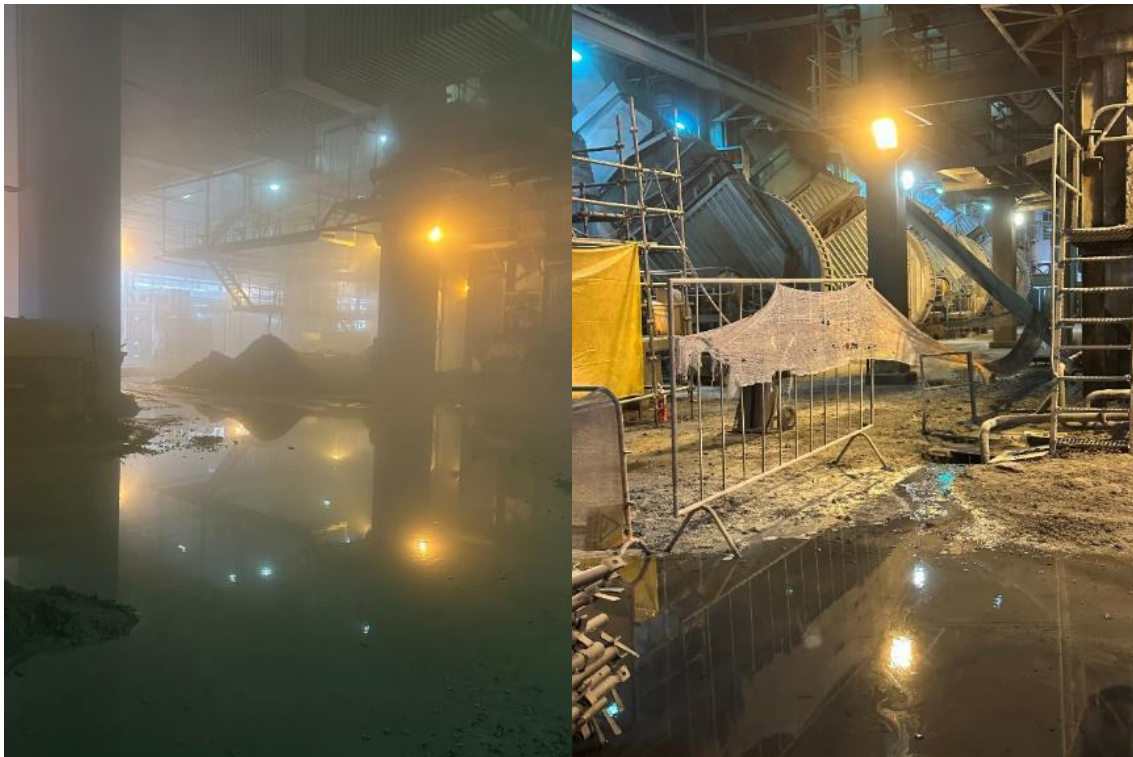
Figure 29: Example of poor housekeeping at Arnot power plant

The status of the housekeeping is unacceptable. Even if it has no direct impact on plant performance, it is important to keep it at an acceptable level so that it is possible to work safely in the boiler house at all times. During the visit, the plant team promised to immediately take steps to improve the situation. They agreed to send photos after implementing corrective actions. These photos were sent on the 7 May 2023 and showed a significant improvement in the situation.

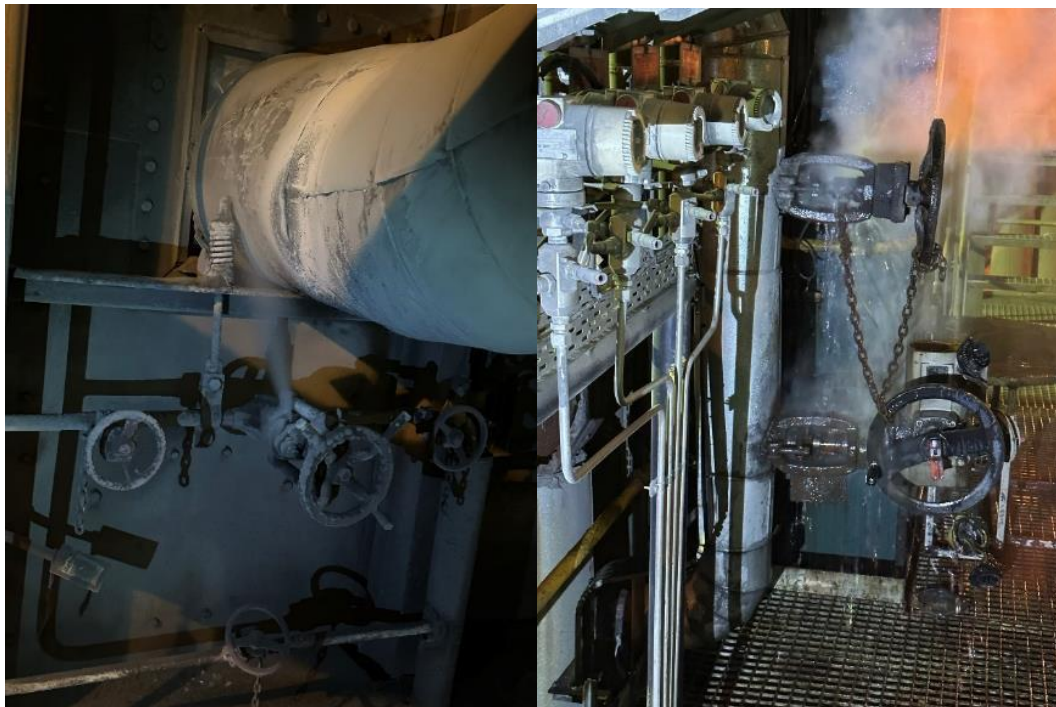
Lots of steam and water leakages were identified. Figure 31 shows examples of leaking valves, one of them located on the steam system.

Figure 31: Examples of steam and water leakages in Arnot's boiler house

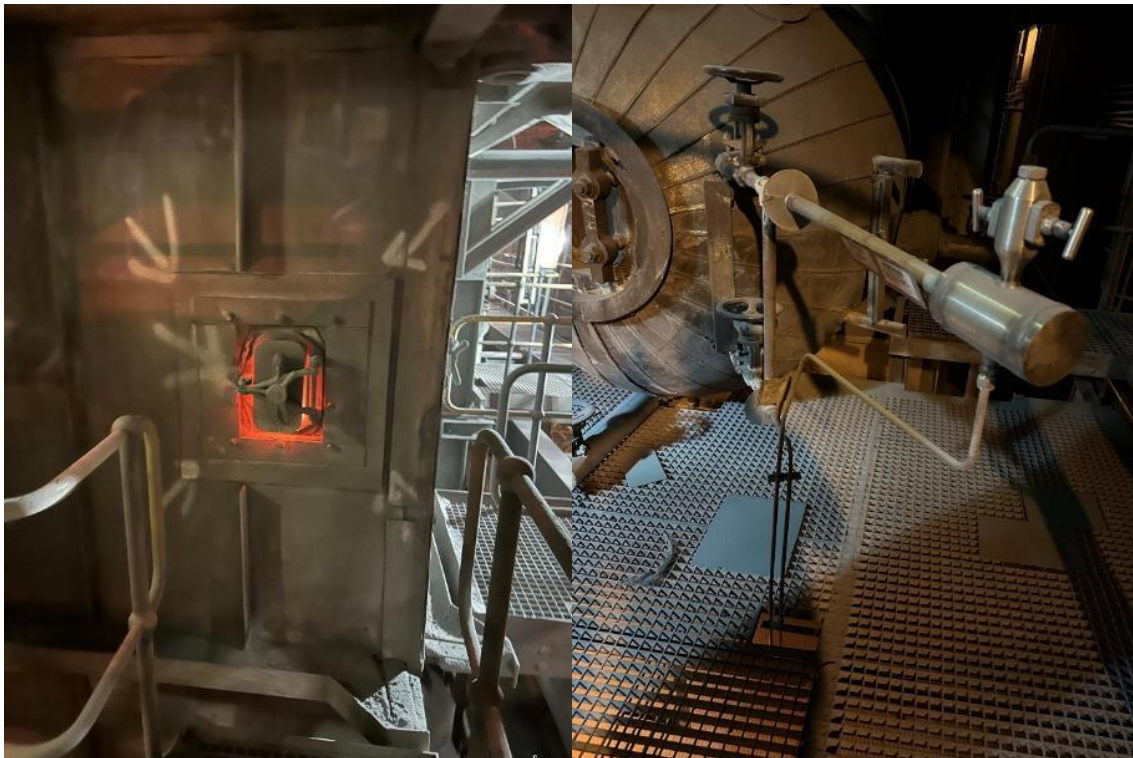
Figure 33: Examples of poor insulation at Arnot

We strongly recommended changing and improving this situation in the short term. The site team should systematically check where uninsulated components are present and insulate these areas, so that the cover temperature does not exceed 45°C maximum.

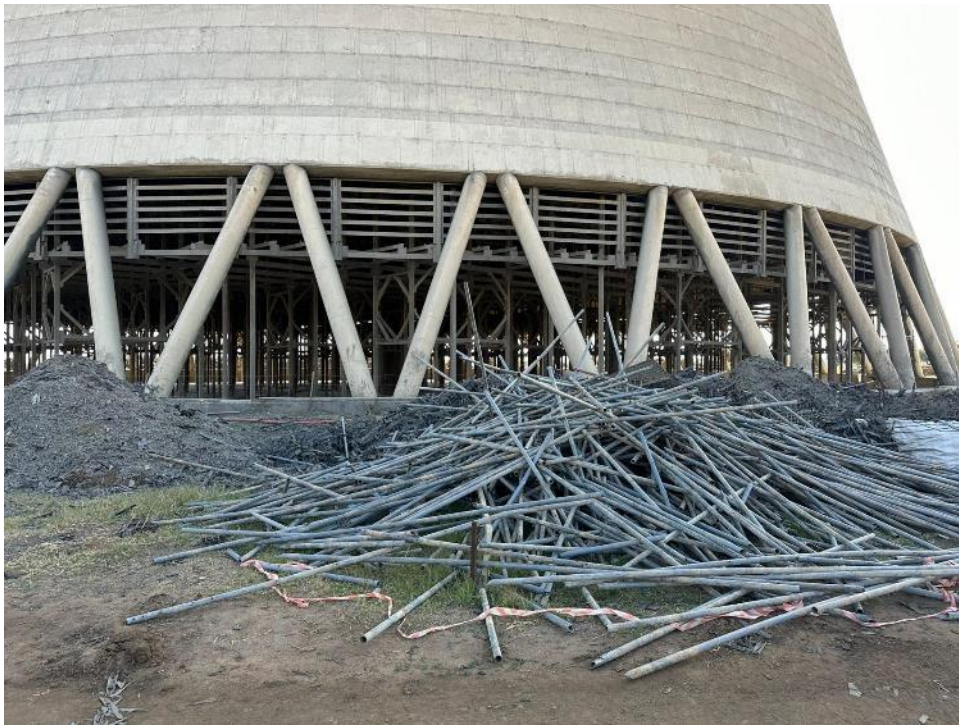
Due to the damaged, brittle cooling tower internals, it was decided that the lower layers be removed (Figure 34). According to Eskom's calculations, the remaining layers are sufficient for the required cooling capacity.

Figure 34: Removed filling of Arnot's cooling tower

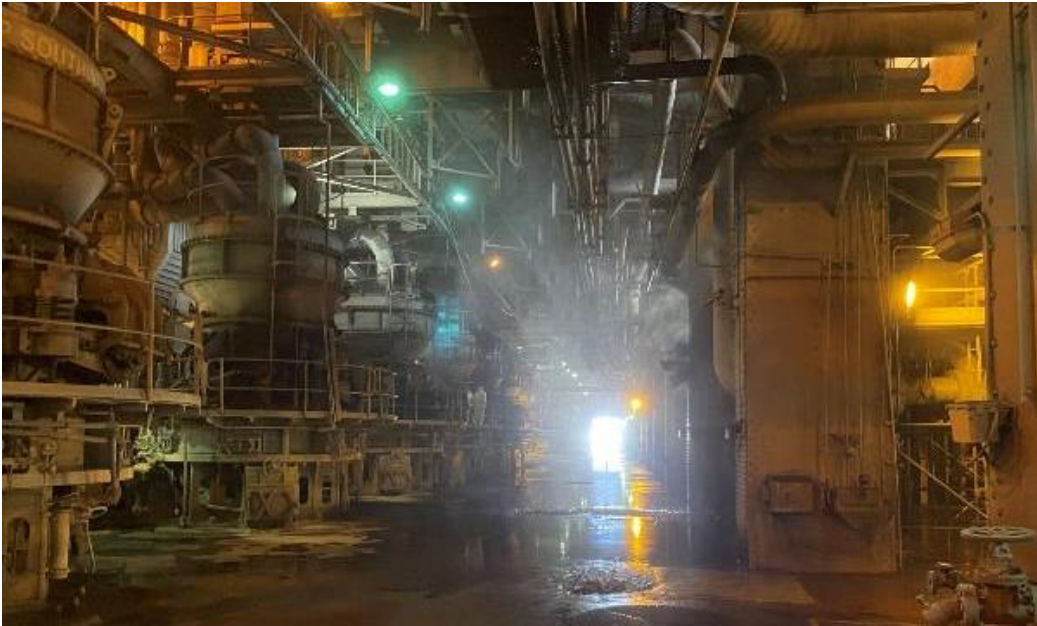
Housekeeping: During the visit, the team walked through the boiler house. Housekeeping was deficient. High amounts of dust, ash and coal were on the floor and machinery (see Figure 44). Safety-related issues could occur due to insufficient housekeeping.

Figure 44: Camden boiler house with steam and water leakages

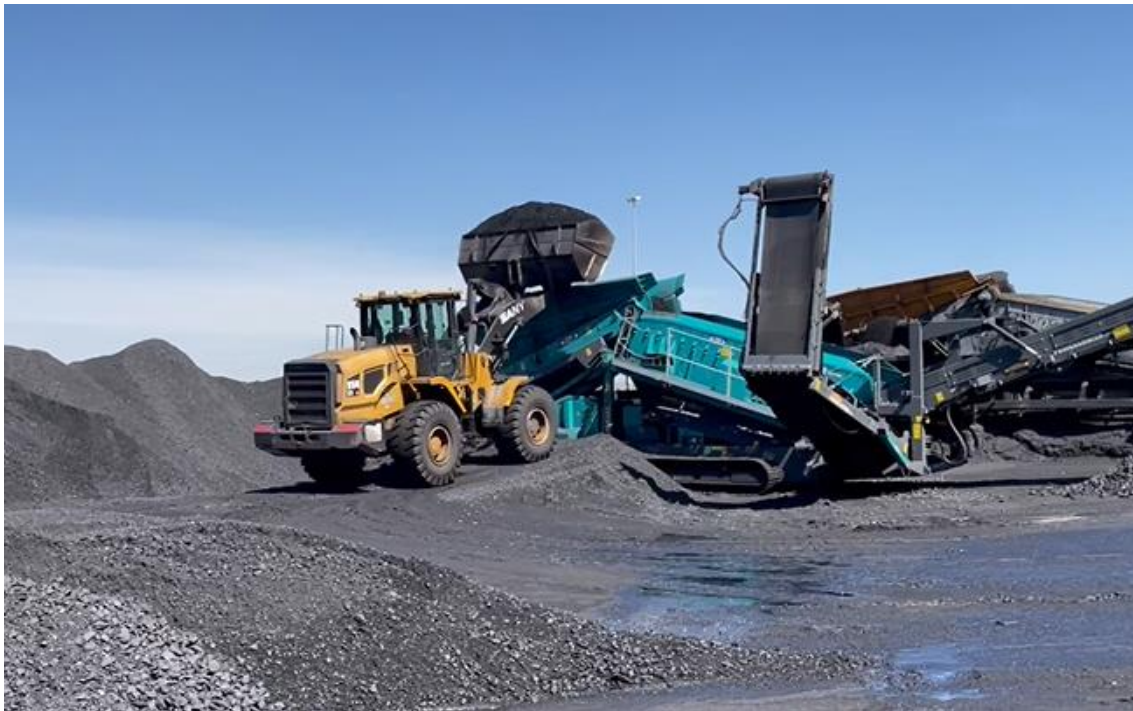
It was reported that the mill casings have been cracked by the stones/rocks contained within the coal.

Figure 47: Coal stockpile management at Camden power plant

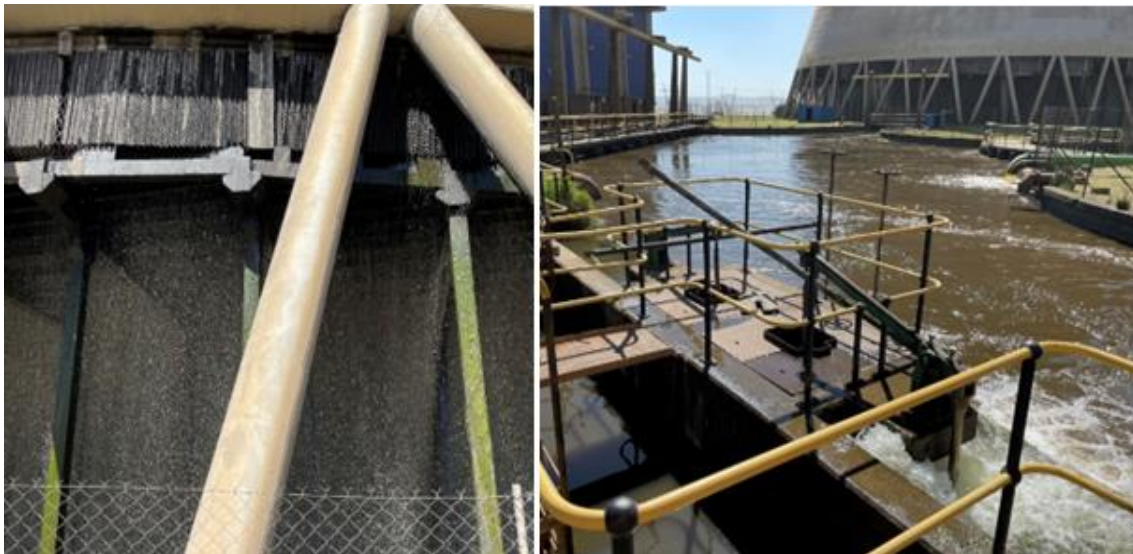
Furthermore, according to the power plant management, the pipework for the cooling water is also badly corroded. The cooling water circuit should be checked for particle entrance points and particle procedures causing this problem. Corroded pipework needs to be replaced, otherwise it will jeopardise plant operation.

Figure 48: Camden's cooling towers with bio fouling (left) and dirty cooling water (right)

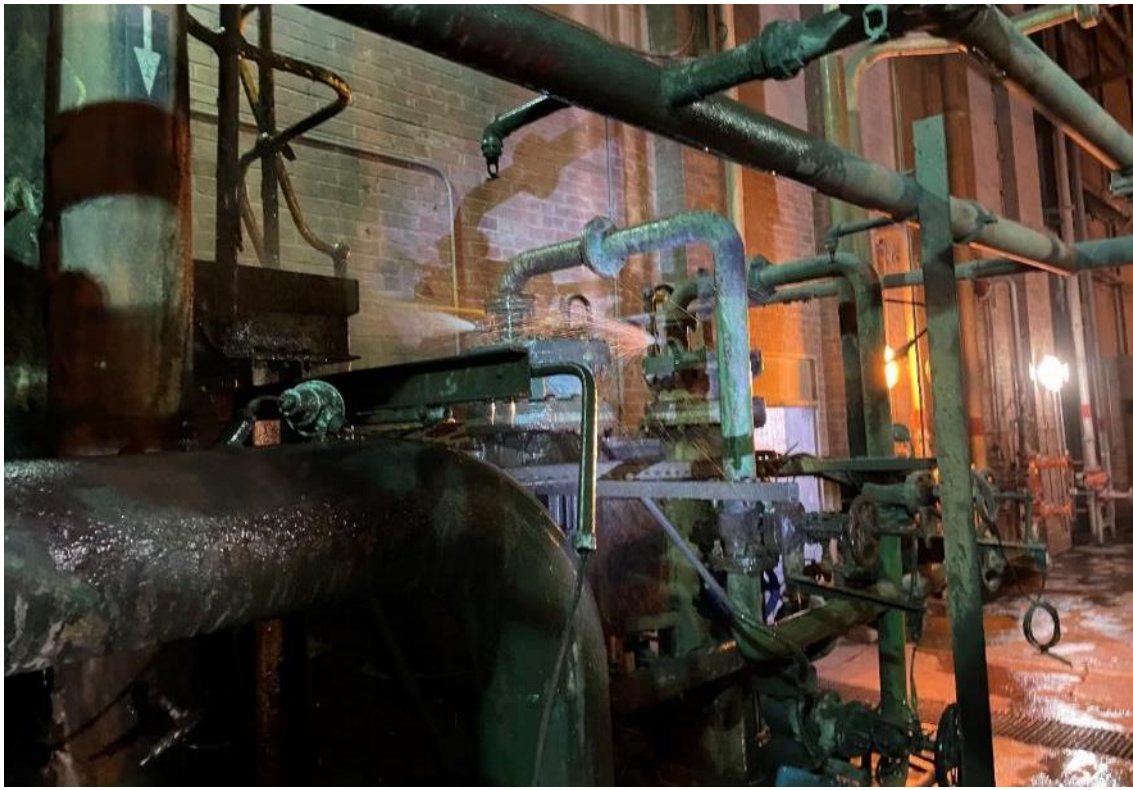
The site staff reported increased vibration on some units due to poor alignment, which can lead to increased bearing temperatures. The increased bearing temperatures cannot be handled by the lube oil coolers, and therefore the coolers themselves also have to be cooled by water from outside (see Figure 50). The used water runs onto the measuring equipment and electrical installation below, so that a malfunction cannot be excluded.

Figure 50: Camden's turbine lube oil cooler with additional external water cooling

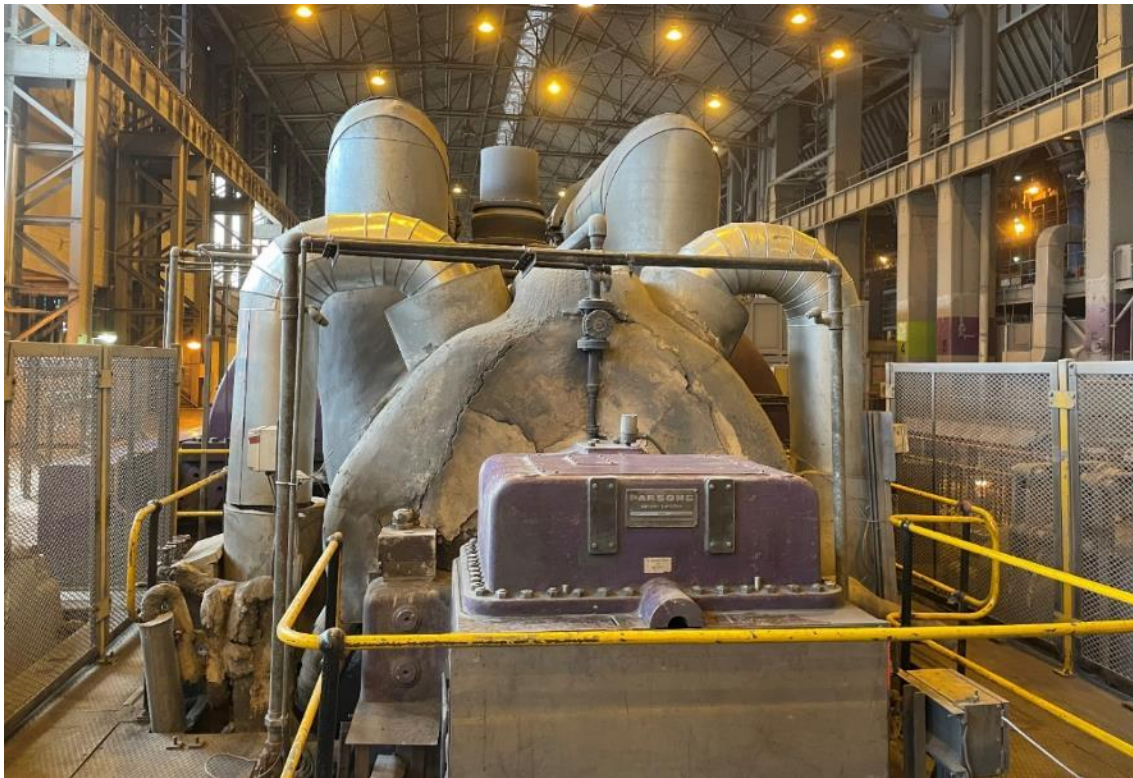
The insulation of some units was cracked, with a visible amount of steam rising from the cracks. One reason for this could be the steam leakages at the horizontal split joint (see Figure 51). Insulation that is no longer intact can lead to temperature differences within the casing. The temperatures differences occur most frequently between the upper and lower parts of the casing. Temperature differences can lead to buckling of the turbine casing, which can cause turbine vibrations. It is also necessary to check whether the insulation causes asbestos pollution.

Figure 51: Turbine with cracked spray insulation at Camden power plant

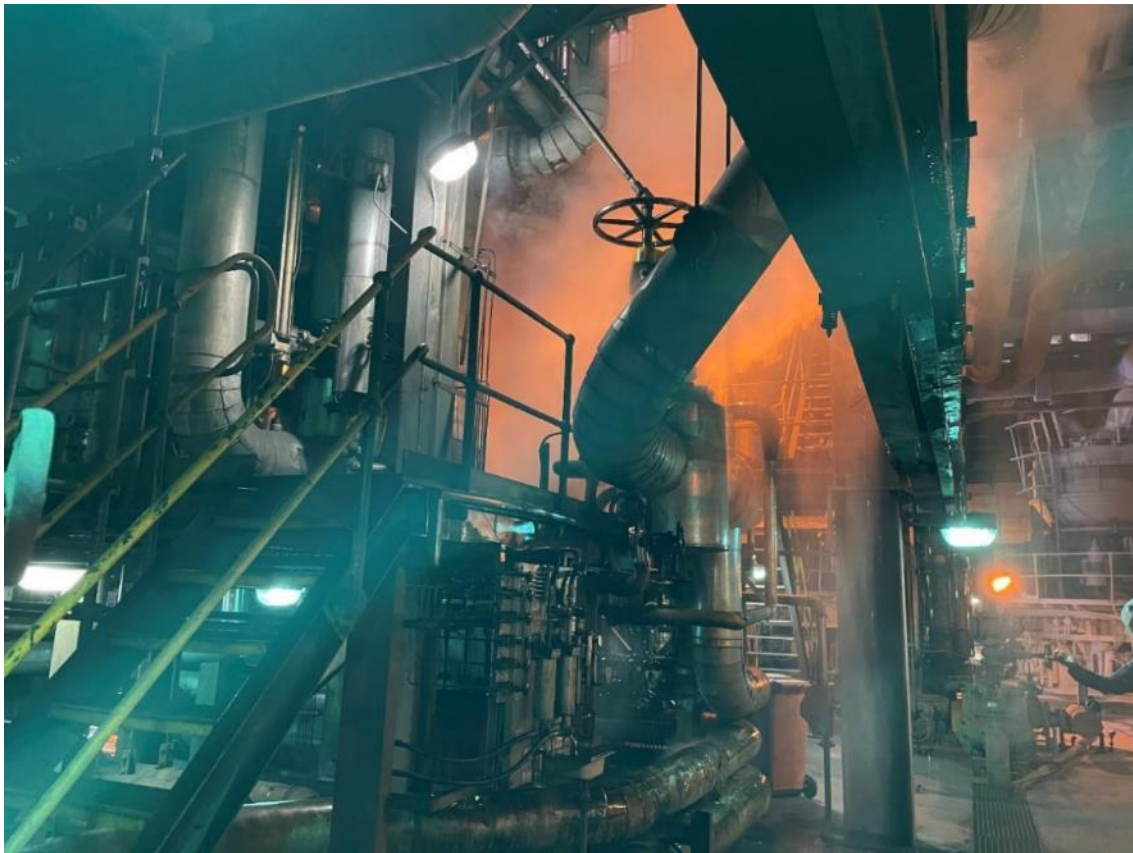
Figure 52: Steam leakages on the lower floors of the Camden machinery house

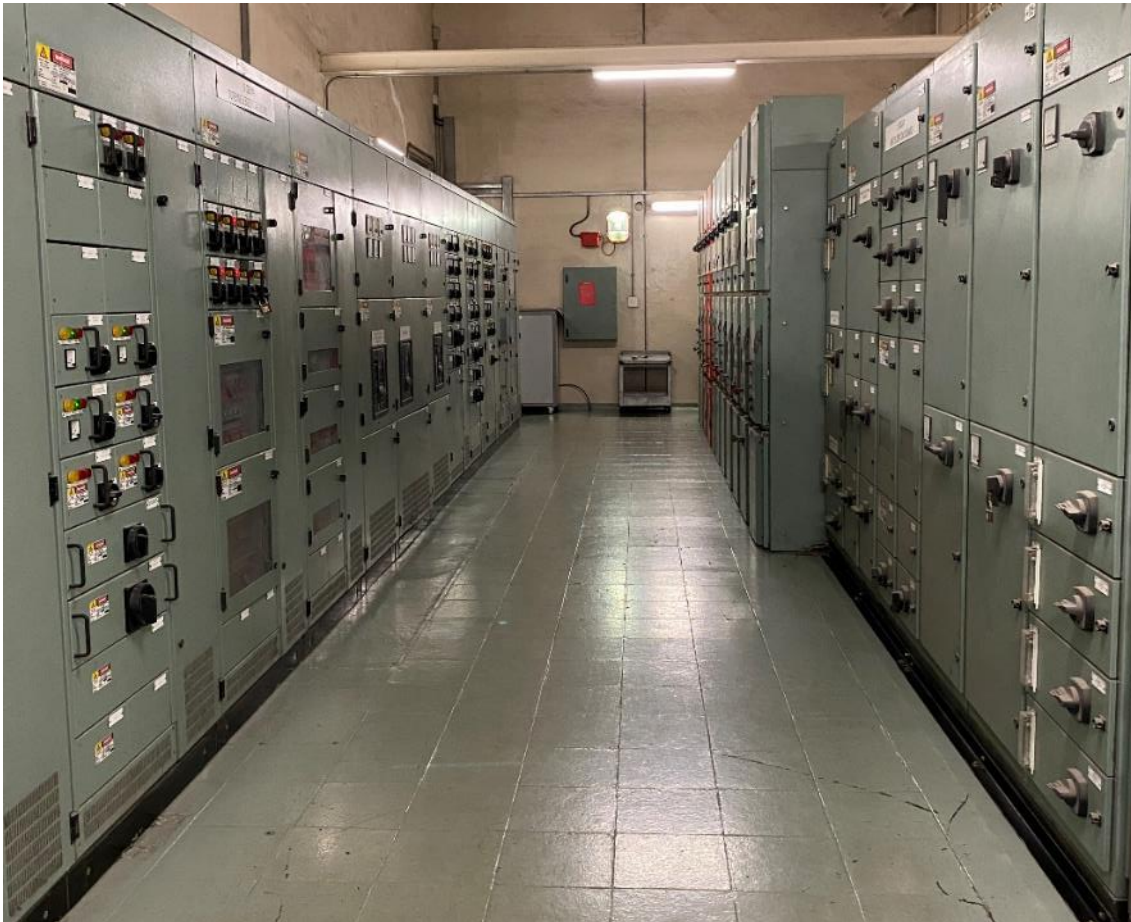
MV & LV Switchgear: The MV and LV board rooms are generally in good condition (see Figure 53). They were replaced during mothballing and are cleaned well. However, the HVAC systems in those areas are not performing as they should.

Figure 53: Clean and refurbished board rooms at Camden

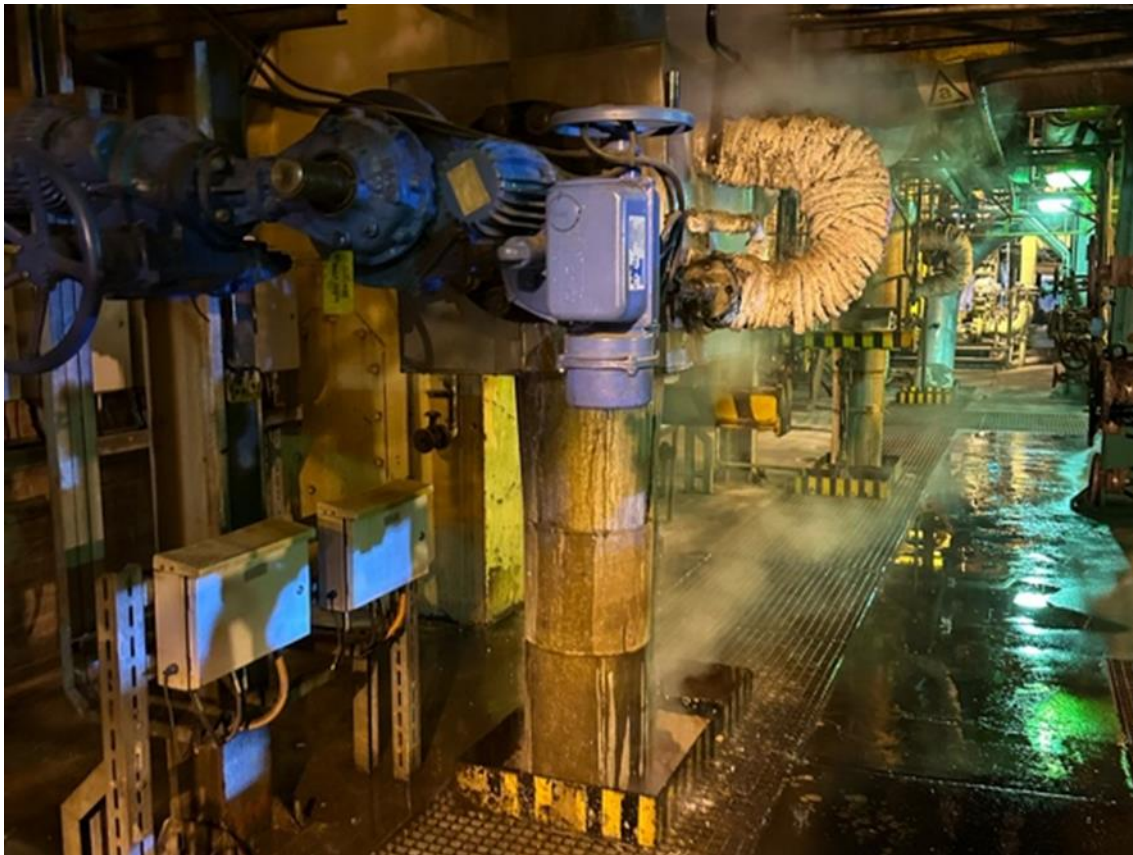
In the boiler house, numerous **steam leakages** at various positions were visible. They were both on valves and on the piping itself (see Figure 60). The team was not presented with evidence of a systematic approach to addressing leakages. It seems as if leakage has become an accepted norm over time and that it has been this way for a while. We strongly recommend that repair work is started immediately.

Figure 60: Leakages at Duvha boiler house

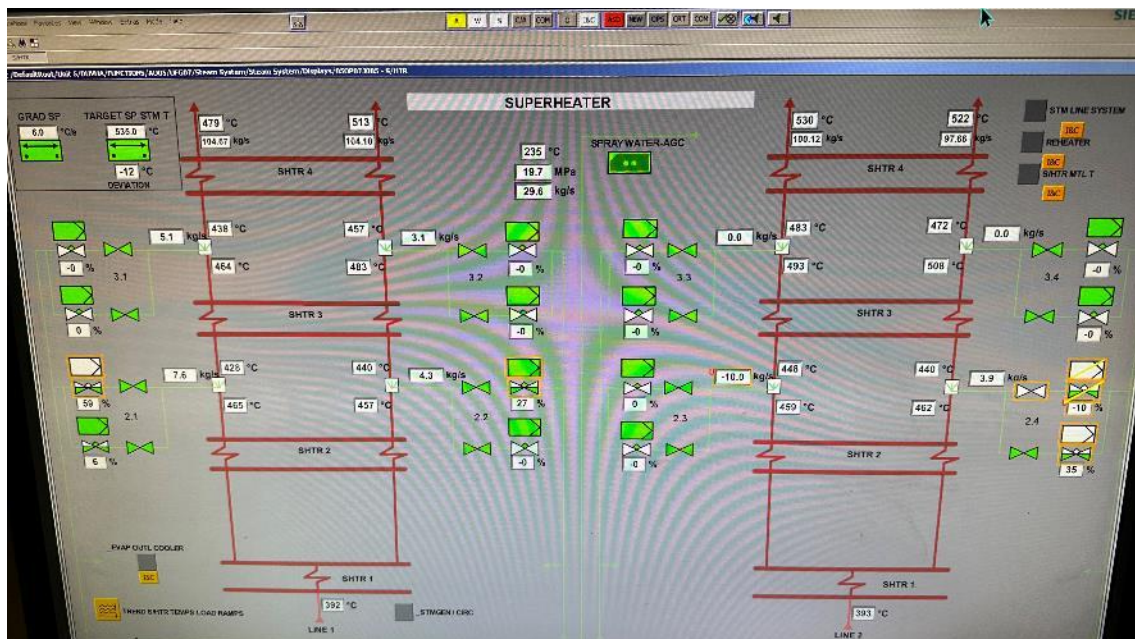
Steam temperatures at the boiler outlet are lower than design. We observed a significant temperature differential between the different sides of the boiler. The spray injection valves were identified as the root cause – these valves are obviously not tight. This results in the temperature of SH steam being far too low (479°C – 530°C, see Figure 61). The desired operational temperature is 535°C. Such a temperature reduction clearly leads to a significant decrease in plant efficiency and output. A reduction from 535°C down to an average of 500°C corresponds to a power loss of approximately 40 MW.

Figure 61: Temperatures of SH inlets and outlets at Duvha

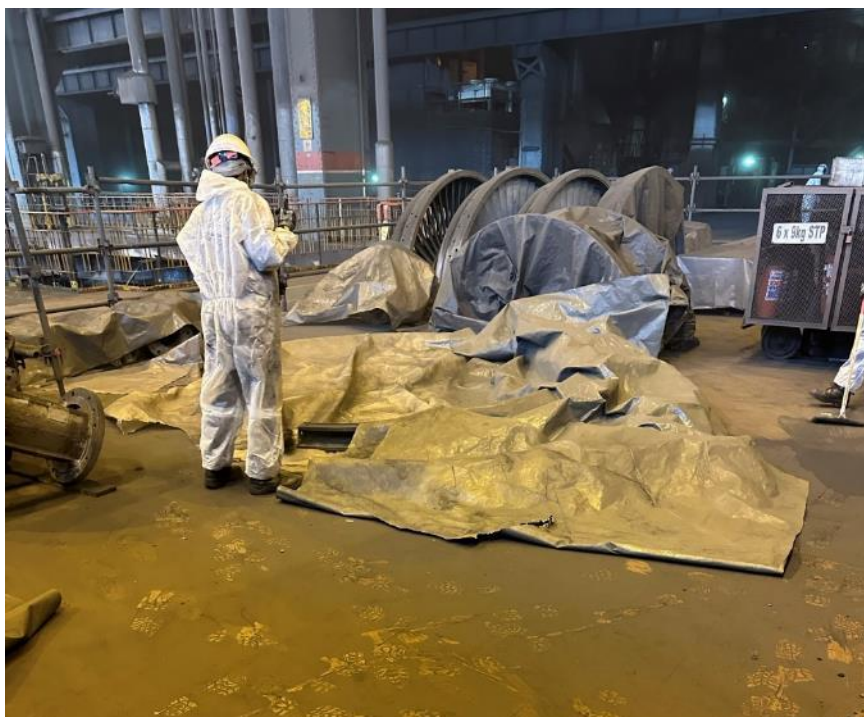
Figure 71: Turbine maintenance in dirty conditions at Grootvlei

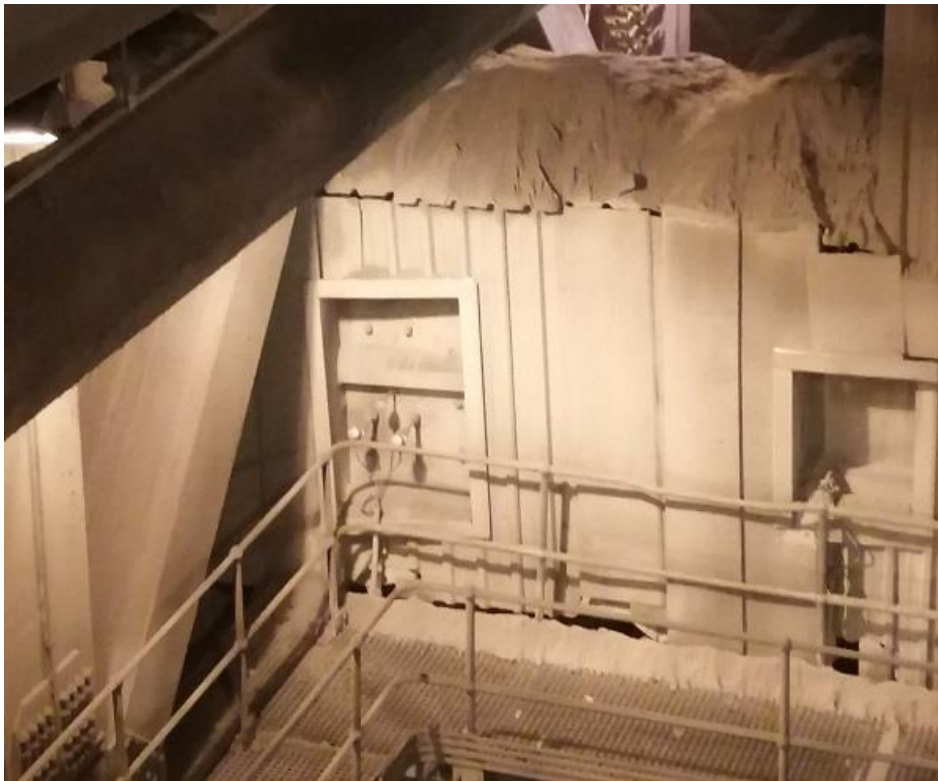
Figure 95: Kendal Unit 2 – PAH duct covered in ash and dust (April 2023)

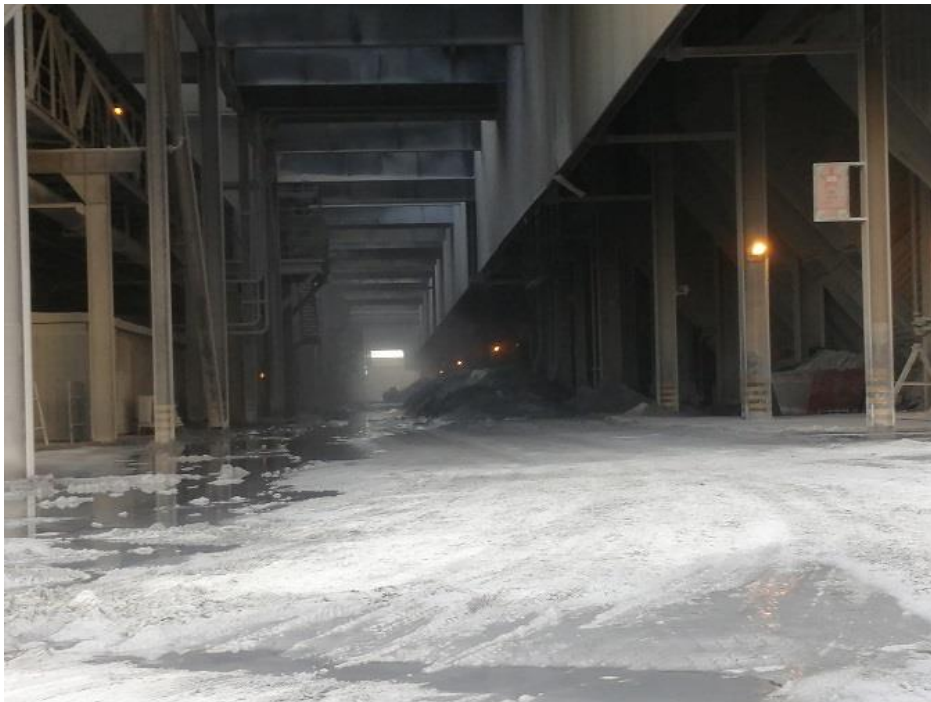
Figure 97: Back of Kendal's boiler at ash handling plant
Ash everywhere with water covering the floor. Dust in the air visible: May 2022²⁶

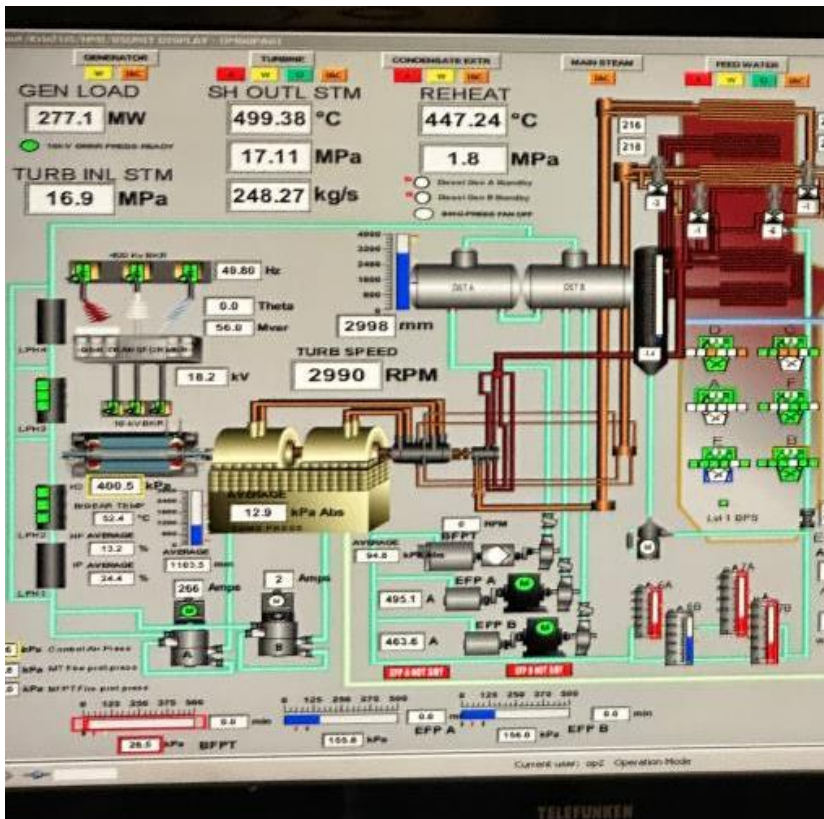
Figure 109: Low reheat temperatures at Kriel

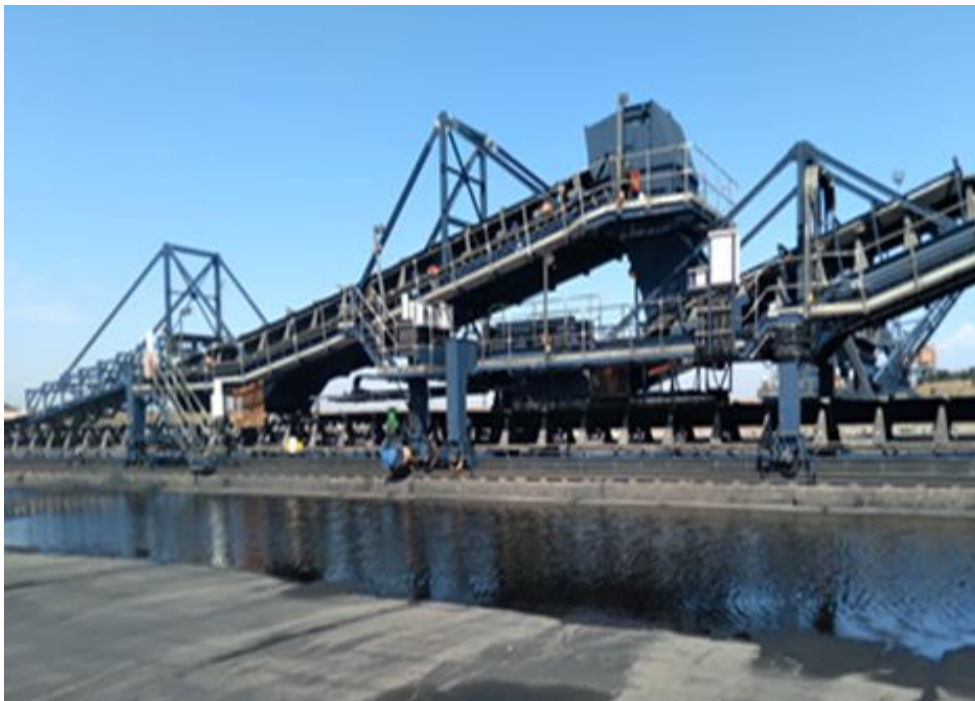
Figure 125: Water logging in Kusile's coal handling plant

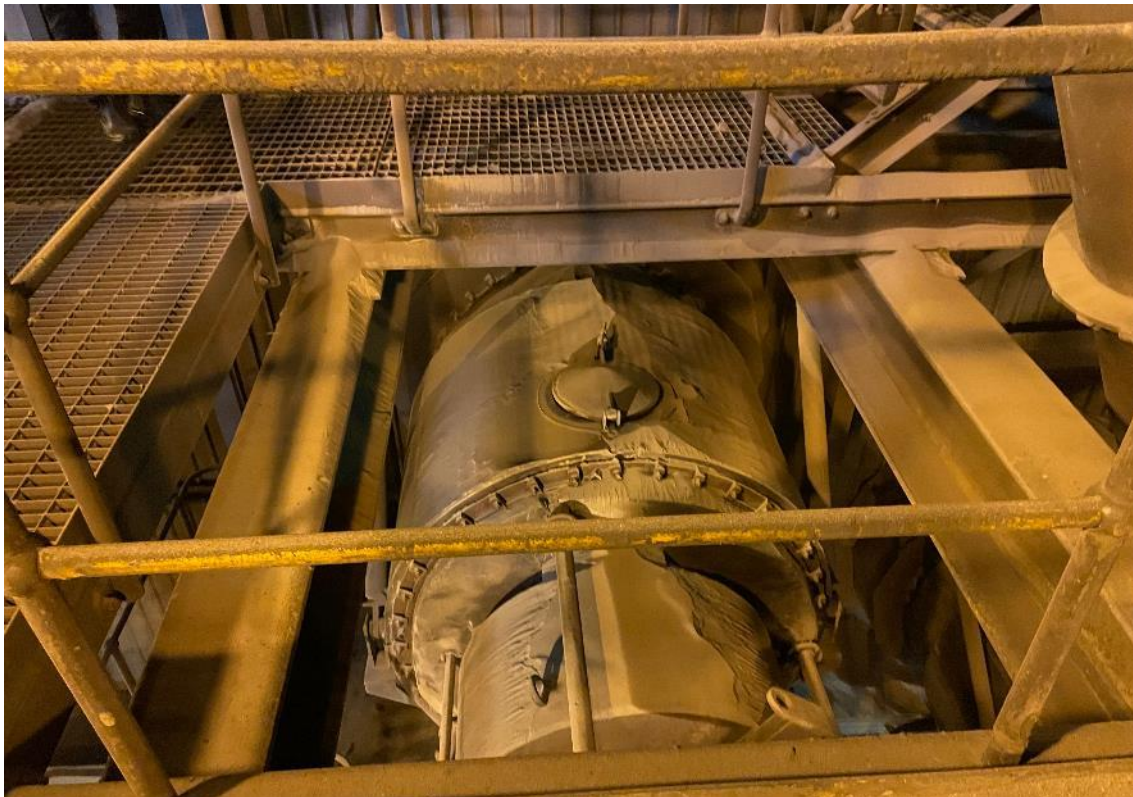
Figure 142: Majuba boilers with a lot of dust due to bad housekeeping

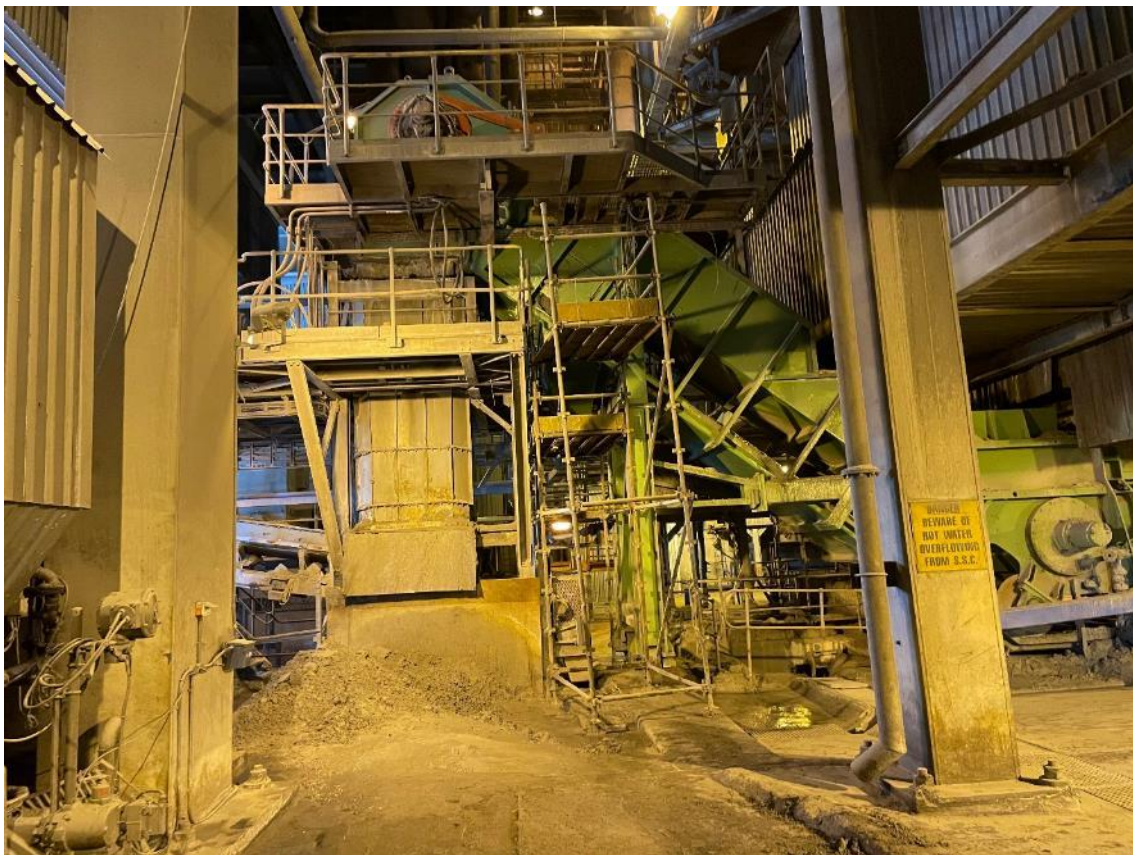
Figure 144: Majuba's ash extraction, emergency disposal – poor housekeeping

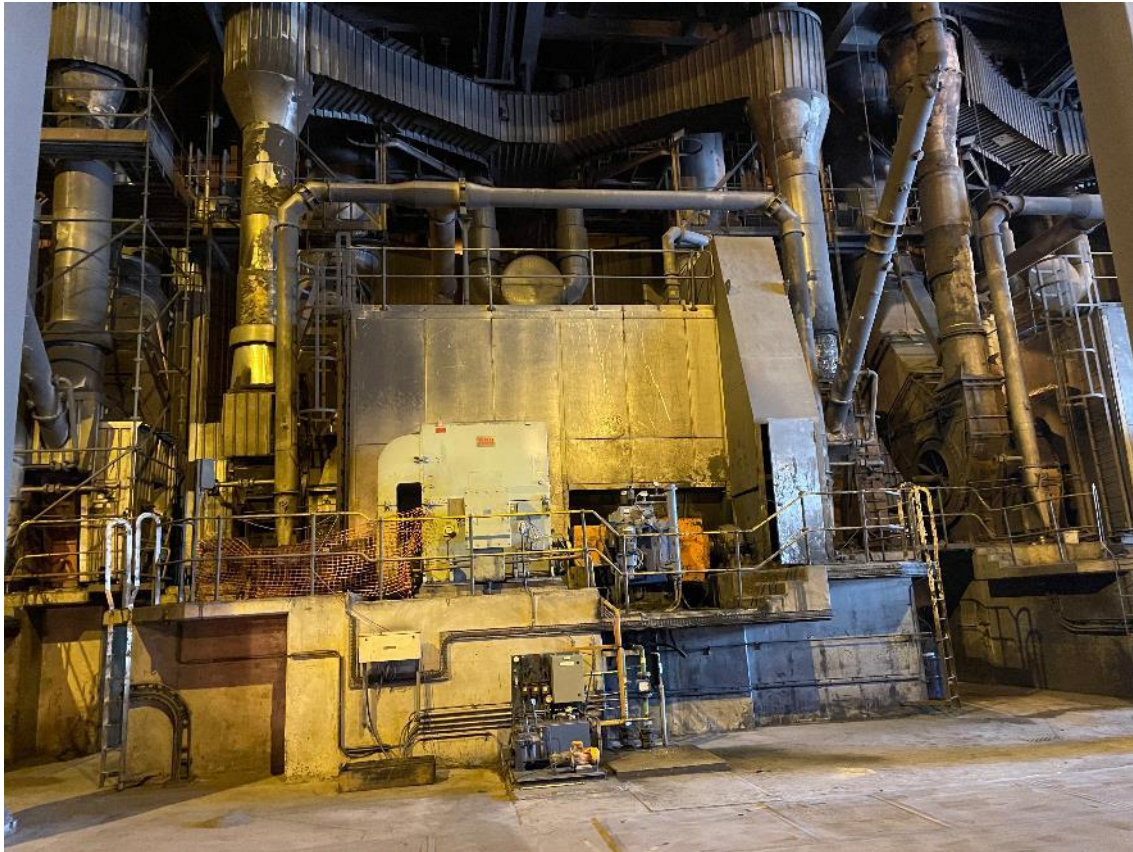
Figure 145: Coal mill at Majuba Unit 1 with patchy canals and overall bad condition

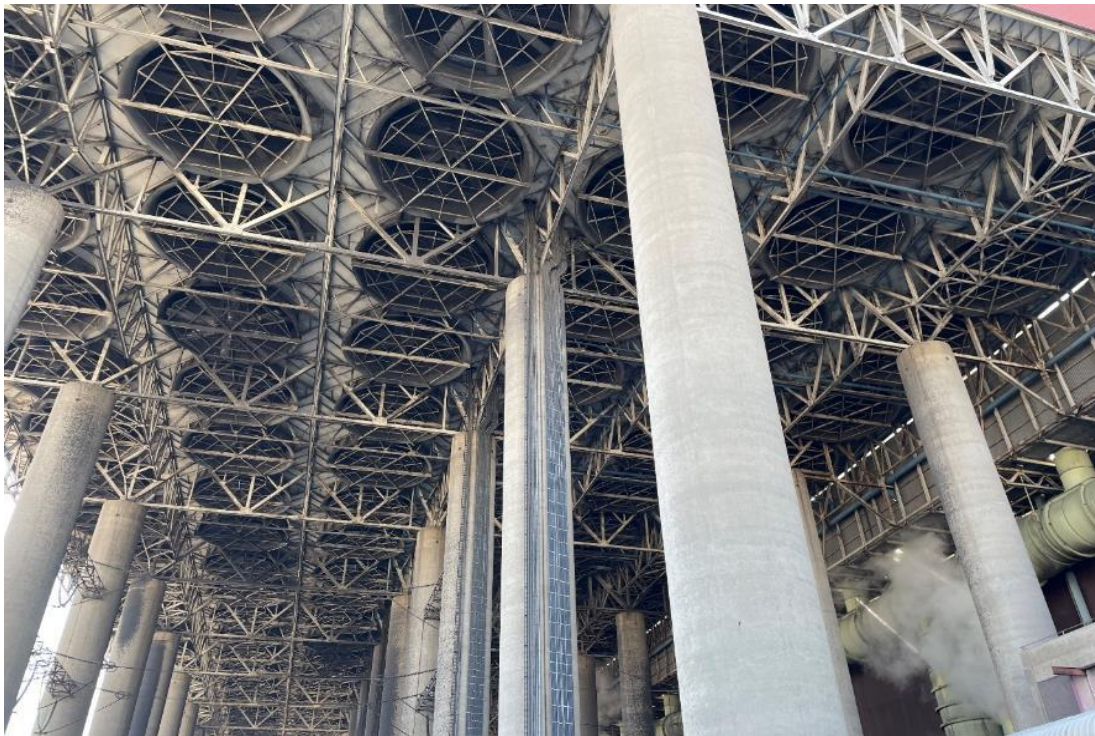
Figure 147: ACC units at Majuba power plant with visible oil residue

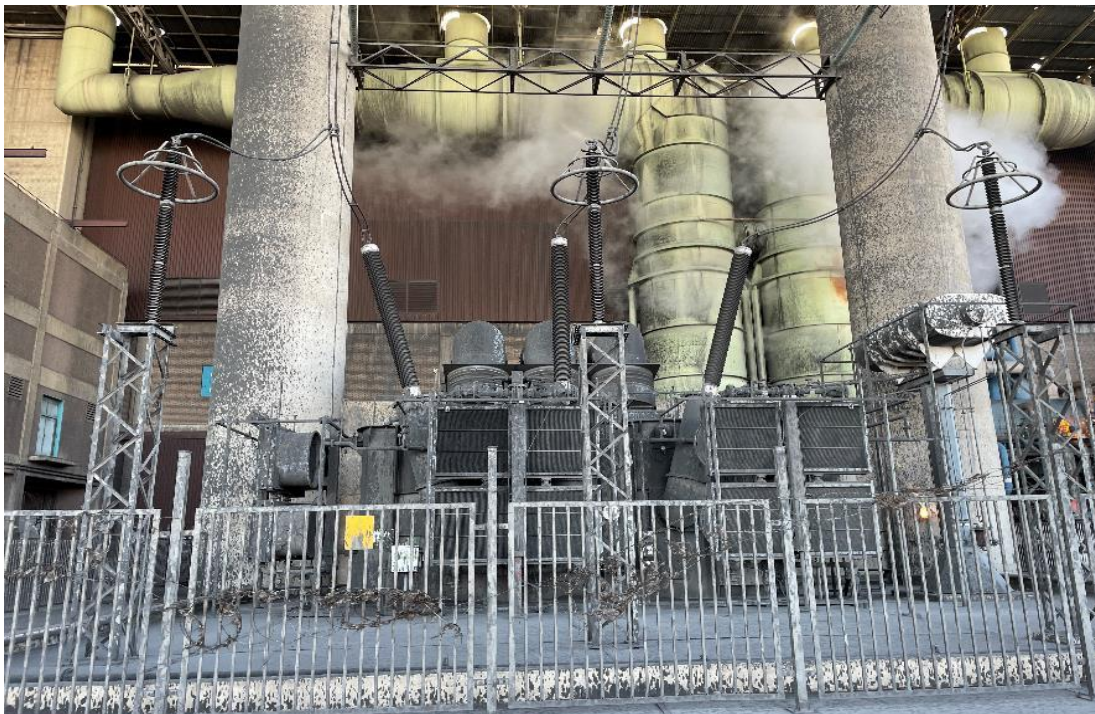
Figure 148: Soiled transformer at Majuba power plant
Covered in grease and oil from the ACC fans

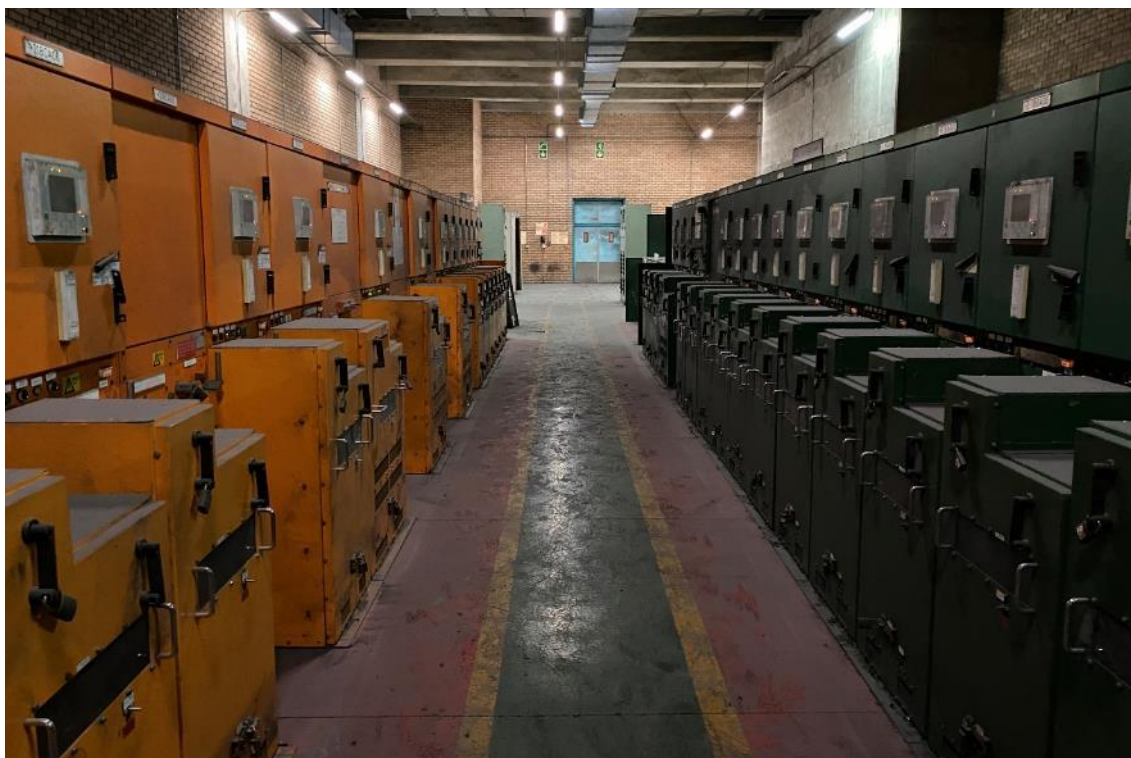
Figure 151: Poor housekeeping within the switchgear building at Majuba power plant

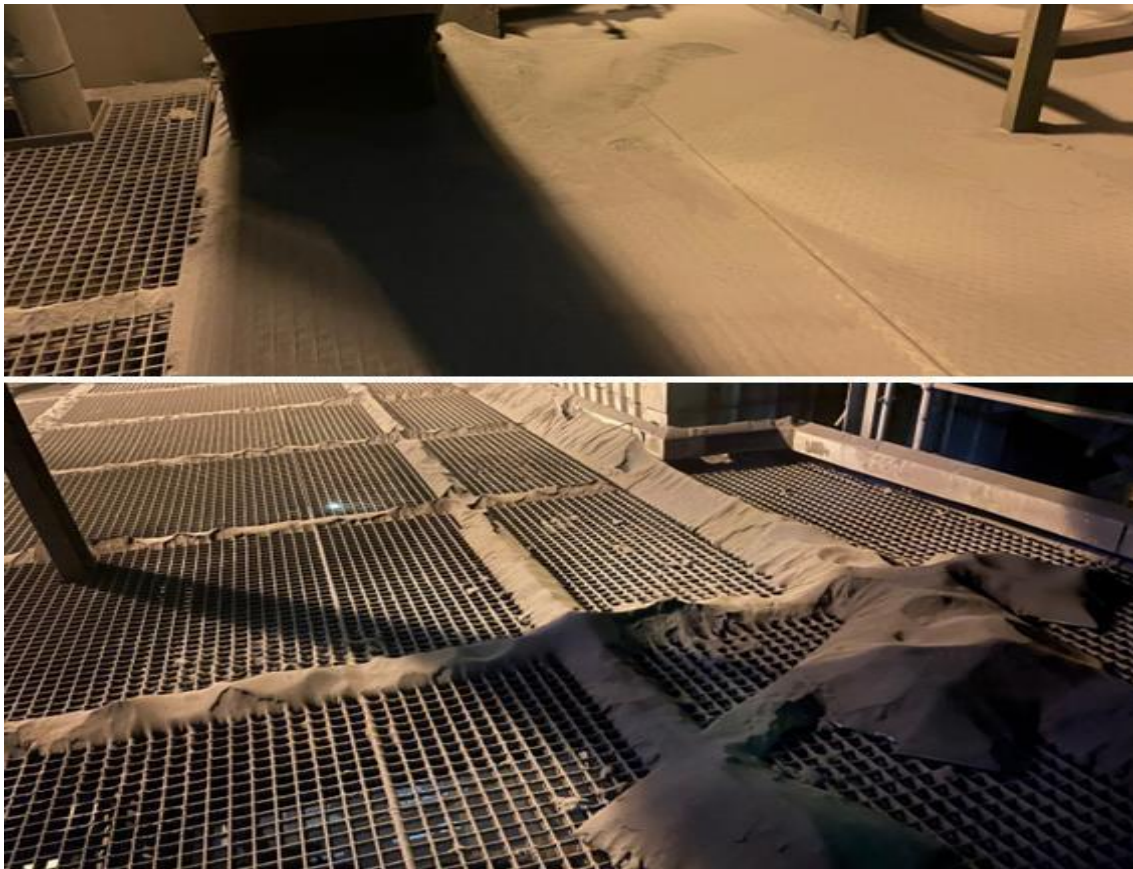
Figure 184: Massive dust pollution at Tutuka's boiler house

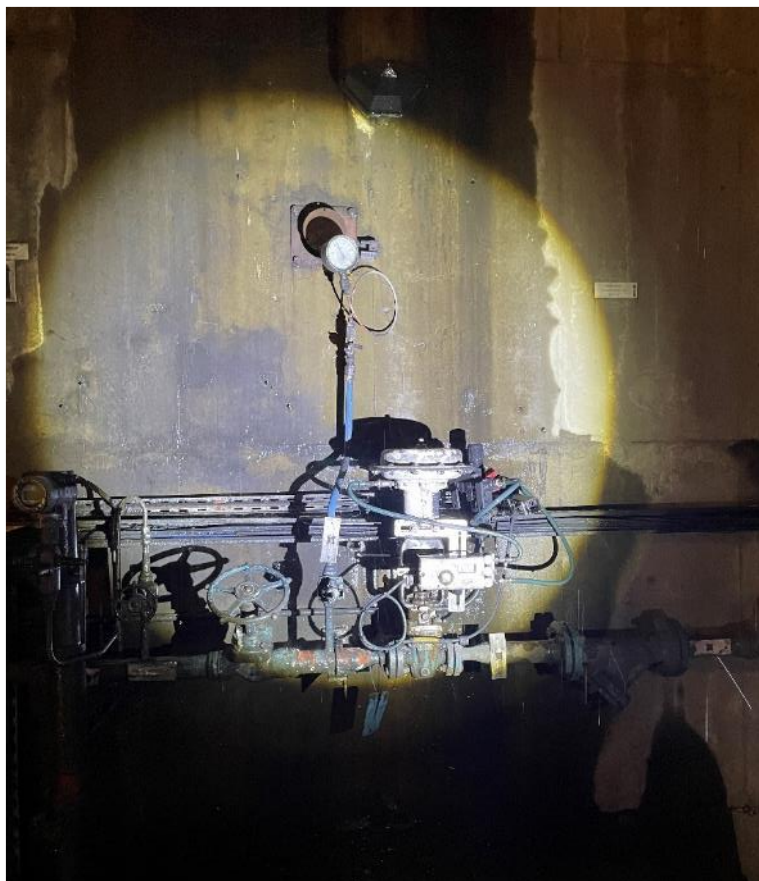
Figure 187: Water/oil leaking on instrumentation and electrical equipment at Tutuka
